Monitoring Data Record

Project Title: U-2524AC COE Action ID: 200321137
 Stream Name: Woodlyn Way DWQ Number: 030909
 City, County and other Location Information: Greensboro, Guilford Co., The stream is located off of the Greensboro Western Loop @ Sta. 57+80 and goes downstream until it intersects with East Woodlyn Way Date Construction Completed: Water was turned into the stream on February 1, 2007 and streambank reforestation was completed on February 15, 2007.
 Monitoring Year: (3) of 5
 Ecoregion: _____ 8 digit HUC unit 03030002
 USGS Quad Name and Coordinates: _____
Rosgen Classification: Proposed reach is a C5 stream type
 Length of Project: 1,250' Urban or Rural: Urban Watershed Size: _____
 Monitoring DATA collected by: M. Green & J. Young Date: 7/27/09
 Applicant Information:
 Name: NCDOT Roadside Environmental Unit
 Address: 1425 Rock Quarry Road Raleigh, NC 27610
 Telephone Number: (919) 861-3772 Email address: mlgreen@ncdot.gov

Woodlyn Way

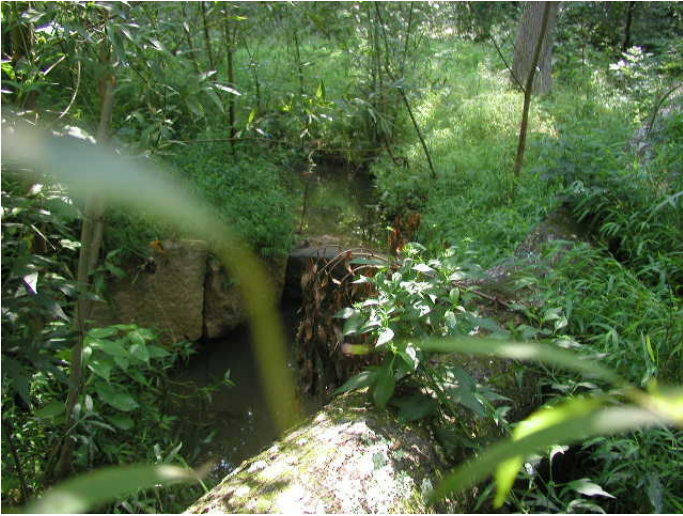
Photo Point #4 (Upstream)

This is the Year 3 Summer evaluation of the Woodlyn Way Stream Restoration Project. The stream is stabilized for this evaluation. It was noted during this evaluation that a large tree had fell across the stream at Photo Point #4. NCDOT will continue monitoring this stream restoration project.
